# Fire Risk Assessment

For Centre Point

## Centre Point, Avondale Square Estate, London, SE1 5NS

ASSESSMENT REF. RB-MEW8HW

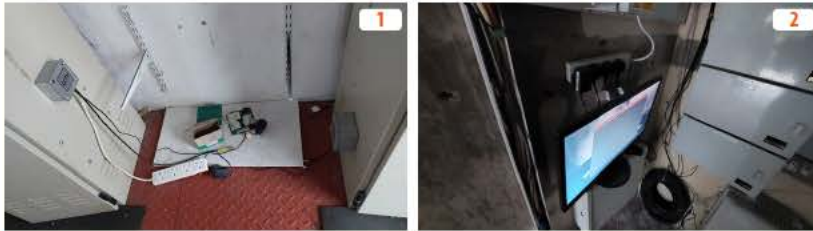
REFERENCE RB-6NR474 DUE 12/09/2025  
LOCATION Lift Motor Room  
CATEGORY City of London: Inspection & Maintenance

The portable electrical appliances within the lift motor room are not being inspected in line with frequencies specified in the policy or appropriate guidance.

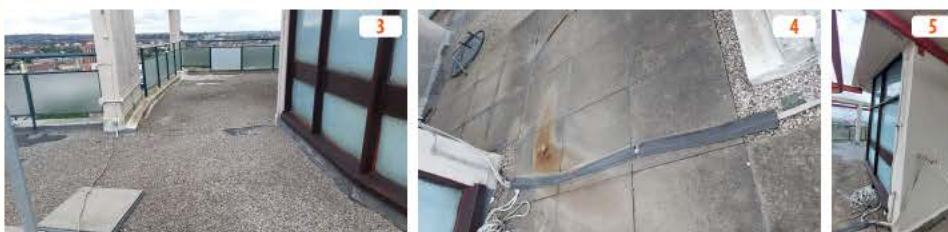
REFERENCE RB-62TBNU DUE 15/11/2025  
LOCATION Site-wide  
CATEGORY City of London: Inspection & Maintenance

No evidence was seen that the lightning protection had been tested within the last 12 months. Additionally the lightning protection installed on the rooftop was seen to be loose, slightly twisted and unclipped from its brackets to suitably secure it.

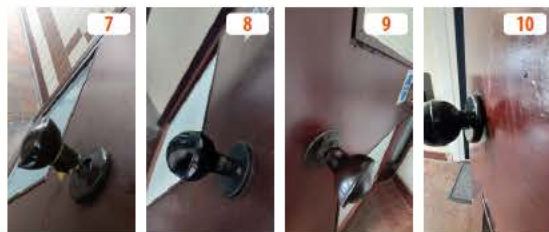
LOCATION 9th, 5th, 2nd and Ground floor.

The communal door handles to the internal staircase doors were quite loose, this may result in it becoming faulty and hinder an effective evacuation.

Ensure the door handles are repaired and in good working condition.

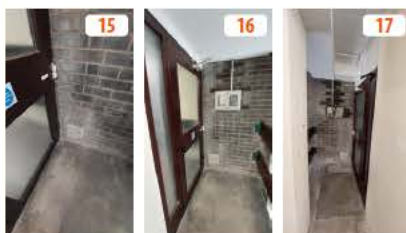
LOCATION 1st floor, internal stair landing

Some of the glazing between the residents' balconies and the internal escape staircase had signs of damage/cracks so may not achieve 30-minutes fire integrity.

It is advised that damaged glazing is replaced with a glass providing at least 30 minutes fire resistance.

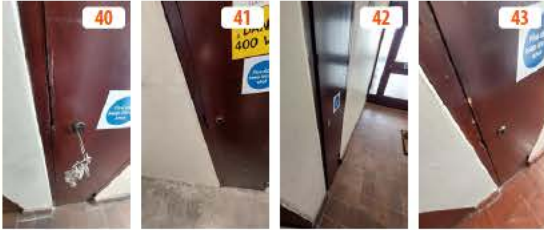
LOCATION Site-wide

A significant number of communal fire doors, particularly those located between the flats and the internal staircase, were found to have multiple defects. Issues included loose glazing, loose beading around glazing, doors not sitting flush within the frame, failure to latch properly, self-closing devices causing doors to slam, doors self-wedging to the ground and excessive gaps around the door edges. These deficiencies undermine the ability of the doors to provide effective fire and smoke resistance along the means of escape.

Ensure a competent passive fire protection specialist reviews all communal fire doors, particularly those serving the internal staircase and flat entrances, to assess their condition. Where necessary, remedial works should be undertaken to ensure the doors are in a maintained, fully functional condition, capable of providing a minimum of 30 minutes fire resistance.

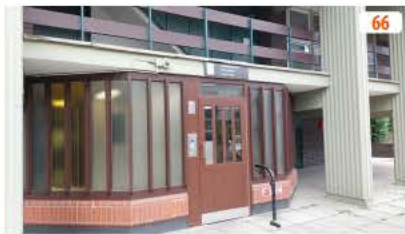
REFERENCE RB-KPX7HP DUE 15/11/2025  
LOCATION Entrance to the building  
CATEGORY City of London: Signage

The dry riser inlet sign is damaged/faded. Also, within the entrance lobby there is no additional signage indicating the exact location of the dry riser inlet.

Advised that, the dry riser sign is replaced. It is also recommended that the text on the sign is amended to state the inlet is in the staircase enclosure or a dry riser sign placed on one of the fire doors between the entrance lobby and the internal staircase (which is where the inlet is located).

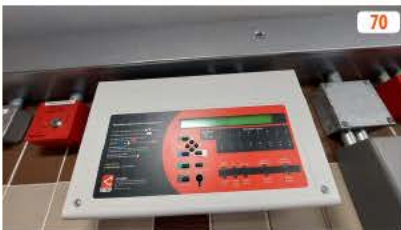
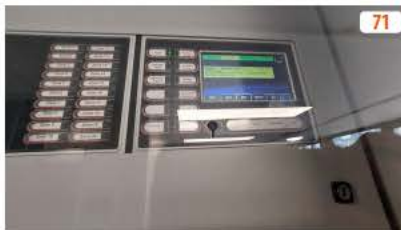
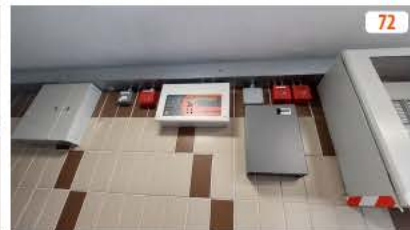
LOCATION Fire detection system, alarm control panel.

It is understood that there has been a proliferation of nuisance / false alarms resulting in the Fire & Rescue Service having to make attendance even where there is no confirmed fire in the building. This is because the fire alarms in the flats and detection in the common areas are linked to an Alarm Receiving Centre (ARC). Activations due to cooking and smoking etc., are automatically sent to the ARC who will call the Fire & Rescue Service to attend to the building. These activations will inevitably cause frustration to residents and the Fire & Rescue Service leading to mistrust in the fire alarm systems and potential that in the event of a real fire, an inappropriate alarm response will be made. This issue has been addressed by the draft Retrospective Fire Strategy for the Avondale Towers.

It is advised that the recommendations of the Retrospective Fire Strategy for the Avondale Towers are implemented in order to minimise the number of nuisance/false alarms and associated fire & rescue service response. This should help in restoring residents' and Fire & Rescue Service confidence in the building's fire alarm systems so that in the event of a real fire, the appropriate evacuation response is taken.
