Defoe House

Barbican Estate

External Fire Risk Assessment

Prepared by: Turner & Townsend

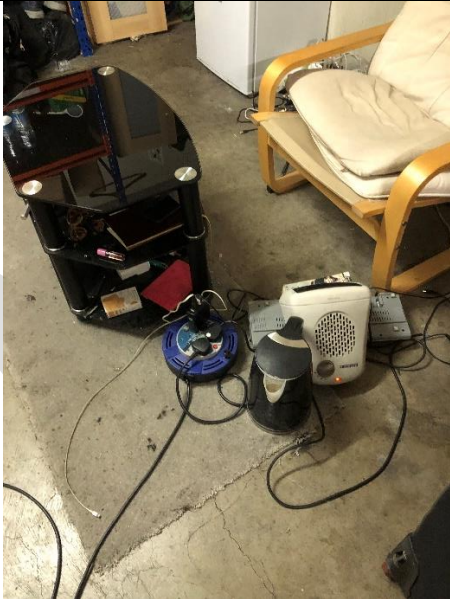
Portable electrical appliances seen in the cleaners Storeroom had no obvious PAT labels. A fan heater was being used next to combustible furniture and cables and a kettle were on the floor where they could be easily damaged. **See Action 3**

<p>3</p>	<p>Cleaners Store</p> <p>Portable electrical appliances seen in the cleaners Storeroom had no obvious PAT labels. A fan heater was being used next to combustible furniture and cables and a kettle were on the floor where they could be easily damaged.</p>	<p>Ensure any portable electrical appliances used or stored in the Cleaners Store are PAT tested in accordance with CoL policy.</p> <p>This area should be managed to ensure combustibles are kept away from heaters and to ensure electrical appliances and cables are not damaged.</p>

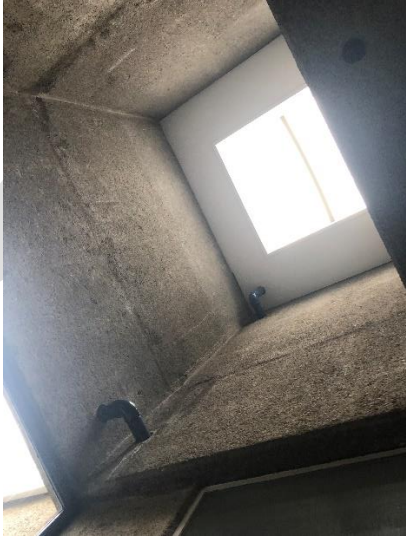
There is no smoke ventilation at the head of the non-firefighting stairways (other than some windows that can be opened from the outside only). It appears that there could originally have been open vents at the heads of the stairways which may have been removed by new window installations.

It was recommended in the Arup retrospective fire strategy for Andrew House, (which is of a similar design to Defoe House), that for escape purposes Automatic Opening Vents (AOVs) should be installed in the stairways. **See Action 7**

<p>if so that they may have been removed by new window installations.</p> <p>It's recommended in the Arup retrospective fire strategy for Andrew House, which is of a similar design to Defoe House, that for escape purposes Automatic Opening Vents (AOVs) should be installed in the stairways.</p>						
<p>8</p>	<p>Smoke Ventilation</p> <p>Further to action 7 above, the smoke ventilation in the building appears to be below the expected levels.</p>	<p>It is advised CoL should commission an expert appraisal by a smoke ventilation specialist to consider the adequacy of the existing smoke control arrangements in the building, including any links to the car park.</p>		<p>Low</p>	<p>D</p>

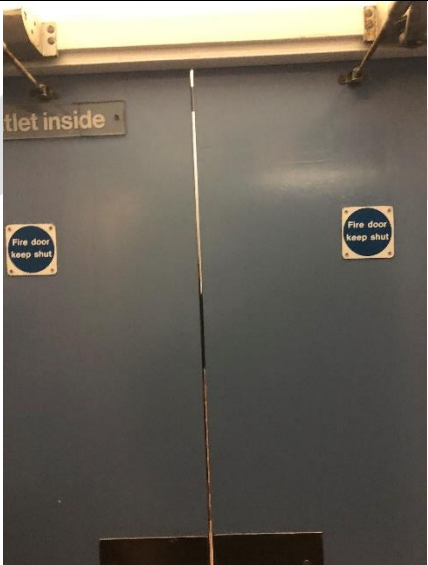
The fire doors / partitions protecting the firefighting stairs do not comply with current standards (which require 120-minute partitions with FD60S doors). These doors are considered to be notional fire doors only and are fitted with Georgian wired glass side panels. Several of the double door sets have excessive gaps between the meeting edges. Several of the single doors do not close fully into their frames as they are warped and/or have been fitted with anti-slam pads. It is understood these doors will be replaced as part of the fire door replacement project. **See Action 12**

<p>with Georgian wired glass side panels. Several of the double door sets have excessive gaps between the meeting edges. Several of the single doors do not close fully into their frames as they are warped and/or have been fitted with anti-slam pads.</p> <p>It is understood these doors will be replaced as part of the fire door replacement project.</p>	<p>of the CoL communal fire door replacement project.</p> <p>It is advised that where any new FD60S fire doors are fitted, the side panels that separate the firefighting stairs from the lift/accommodation lobbies are at least REI 60-minute fire rated.</p>					
<p>13</p>	<p>Planned Preventative Maintenance (PPM)</p> <p>No PPM / statutory inspection records were provided.</p>	<p>Ensure the maintenance of the following systems is up to date:</p> <ul style="list-style-type: none"> • Fixed Electrical Wiring (including Thermographic 		<p>Medium</p>	<p>C</p>

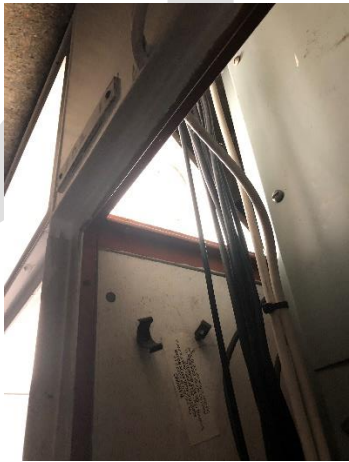
Lift Landing lights - There are light fittings above the lifts. These lights are fitted with metal hoods that separate them from the risers. It was noted that several of these hoods had been displaced, effectively leaving an open hole between the risers and stairwell. **See Action 14**

<p>imagine where required)</p> <ul style="list-style-type: none"> • Emergency Lighting (and any back-up generator) • Dry Risers • Firemen’s Lifts • Smoke Vents - Opening Vents (OVs) • Lightning Protection • Sprinkler System 					
<p>14</p>	<p>Lift Landing lights</p> <p>There are light fittings above the lifts. These lights are fitted with metal hoods that separate them from the risers.</p> <p>It was noted that several of these hoods had been displaced, effectively leaving an open hole</p>	<p>All of the lift landing lights should be checked to ensure that the metal covers are in place with no gaps. Where gaps are identified they should be sealed to ensure that there is at least 30 minutes imperforate compartmentation between the riser and lift lobby.</p>

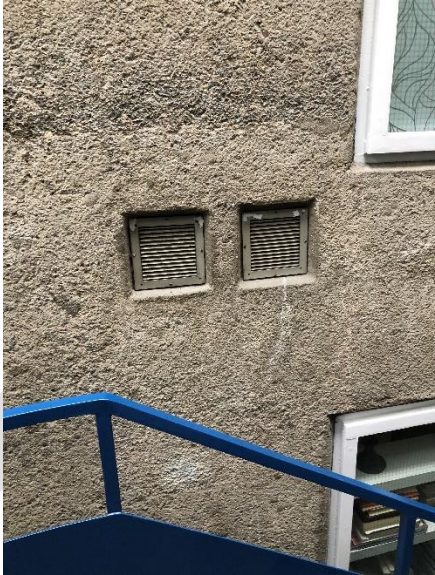
Vents into stairs - Blanking plates are missing from the vents from Flats 51 & 102. It is understood that the vents had been blocked off to mitigate against the risk of smoke entering the communal stairs. **See Action 21**

20, Block	<p>Compartmentation</p> <p>The glazing to this flat has been blacked out so it was not possible to confirm that the original Georgian Wired Glass is still in-situ.</p>	<p>CoL should confirm that the glazing between the flat and the stair will provide at least 30 minutes of fire resistance (e.g. that it is Georgian Wired Glazing).</p>		Medium	C		
21	<p>Vents into stair</p> <p>Blanking plates are missing from the vents.</p> <p>It is understood that the vents had been blocked off to mitigate against the risk of smoke entering the communal stairs.</p>	<p>It is advised that the blanking plates over the stair vents are replaced.</p>

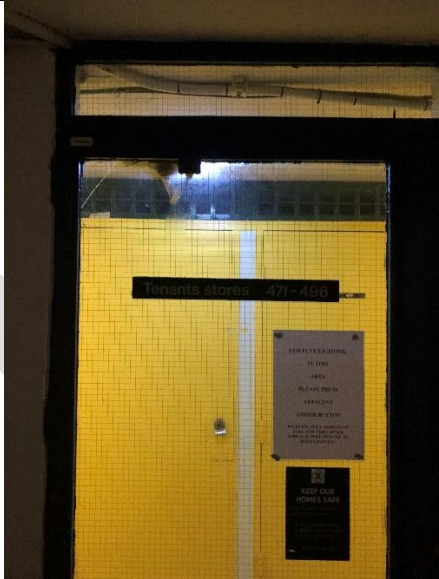
The fire doors to the tenant store areas are generally not in a satisfactory condition – e.g. the door to area 471-496 has cracked glazing. Also, the door to the Pump Room from the Tenant Store has cracked glazing. It is understood these doors will be replaced as part of the fire door replacement project. **See Action 22**

<p>22</p>	<p>Tenant Store Area Fire Doors</p> <p>The fire doors to the tenant store areas are generally not in a satisfactory condition – e.g. the door to area 471-496 has cracked glazing.</p> <p>Also, the door to the Pump Room from the Tenant Store has cracked glazing.</p> <p>It is understood these doors will eventually be replaced as part of the communal fire door replacement project.</p>	<p>In the short term, ensure all the communal fire doors in the Tenant Store areas are fully self-closing into their frames when released from any angle. Any broken glazing should be replaced or covered by a fire resisting material.</p> <p>Longer term, it is advised that all of the existing communal fire doors should be replaced as part of the CoL communal fire door replacement project. It is advised that at least FD30S fire doors are fitted.</p>

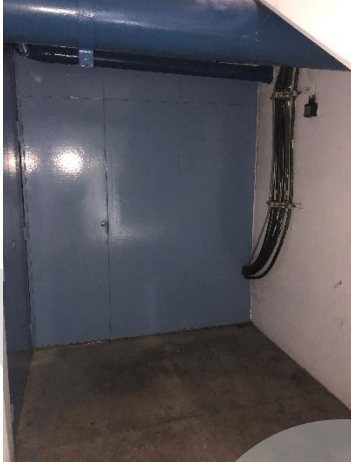
<p>23</p>	<p>Block 29-42 Tenant Store Area Under Stair Cupboard</p> <p>Electric cables penetrating a fire door are not fire stopped.</p>	<p>The service penetrations should be sealed with an appropriate for firestopping material to provide at least 30 minutes fire resistance.</p>
