# Fire Risk Assessment

For Centre Point

## Centre Point, Avondale Square Estate, London, SE1 5NS

ASSESSMENT REF. RB-MEW8HW

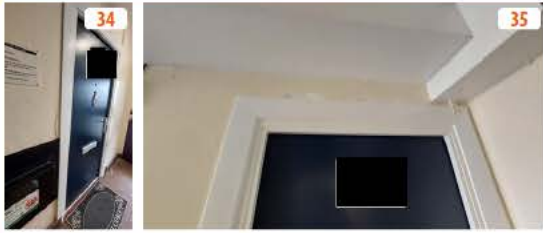
Damage to the wall next to Flat [redacted] and damage above Flat [redacted] where a filler has been used. These defects may compromise the integrity of the compartmentation and increase the risk of smoke spread in the event of a fire.

Ensure a competent passive fire protection specialist reviews all areas where new sprinkler and fire alarm services are breaching compartment walls to identify unsealed or poorly sealed service penetrations. Where found necessary, remedial fire stopping works should be undertaken to ensure the compartments provide a minimum of 60 minutes fire resistance.

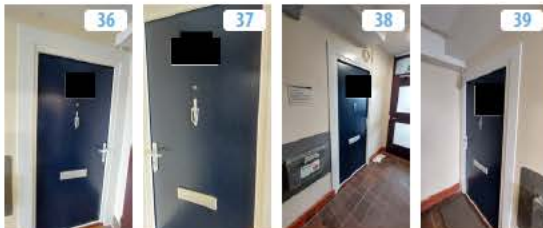
All of the flats have recently been replaced with FD60s Gerda fire doors with internally mounted overhead closers.

The Gerda entrance doors to flats No [redacted] and [redacted] were checked and found to be installed with effective overhead self-closers.

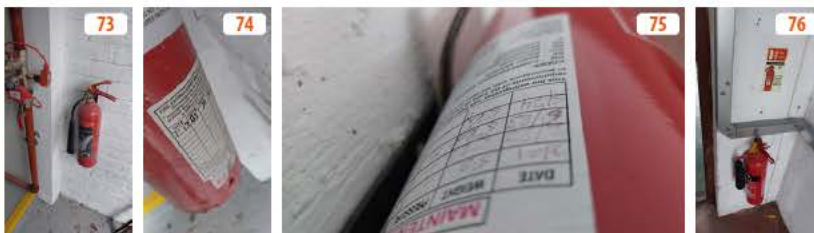
LOCATION Lift Motor Room

Fire Extinguishers are provided in the plant room, external electrical cupboard and lift motor room.

Fire extinguishers are not provided in the common escape areas
